URBAN D.C. Inc.

Marcus Garvey Park
Mt. Morris Fire
Watchtower

Scope of Work

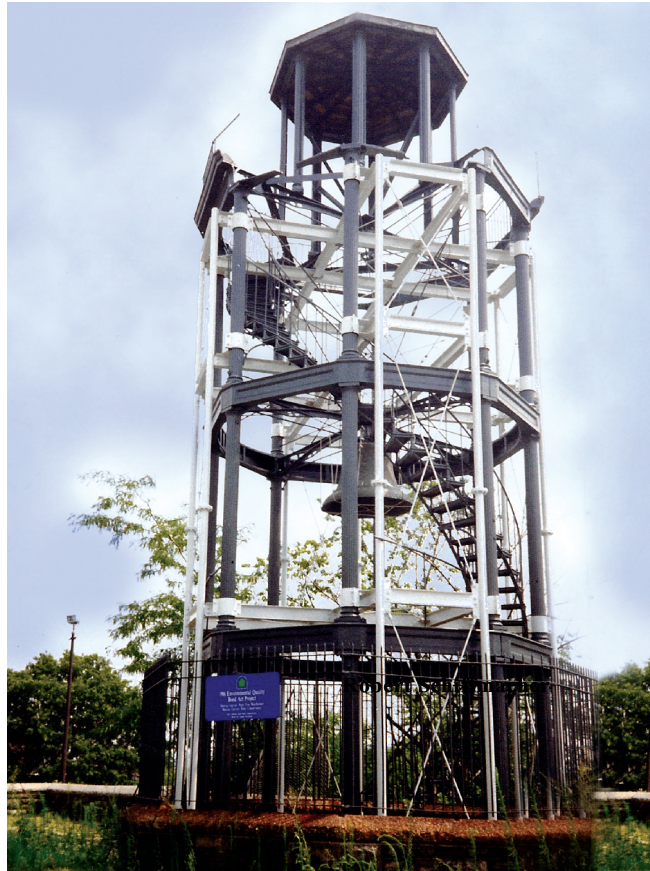
Photos clockwise from top left. Completed structural support system. Parks Dept. representative working with Urban D.C. on structural analysis. Urban D.C. in-house crew underpinning the tower.

Mt. Morris Fire Watchtower, a designated landmark, required emergency stabilization after large cast iron pieces began falling to the ground. The NYC Department of Parks hired specialty contractor Urban D.C. to stabilize the structure with an exterior steel framework. It was necessary for Urban D.C.'s in-house crew to carefully dismantle portions of the tower, in order to repair and recast various pieces around the new steel structure. This fragile structure, the century old example of "constructive expressionism," as quoted by Christopher Gray of The New York Times, was secured. Urban D.C. fabricated and installed new structural footings and finished the assignment with restorative painting.
